# Malposition of a Tunneled Cuffed Hemodialysis Catheter: Where Did the Catheter Go?

<sup>1</sup>Department of Nephrology, Dialysis and Transplantation, Fattouma Bourguiba University Hospital, Monastir, Tunisia

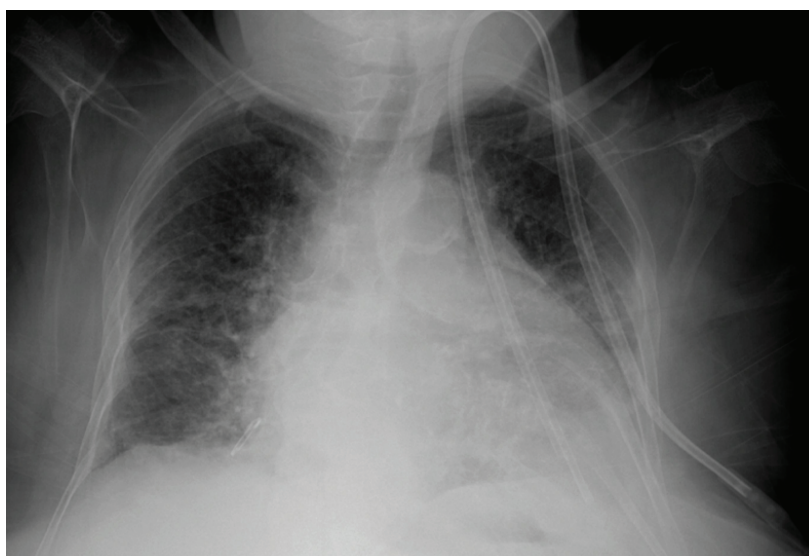
An X-ray of the thorax was performed in order to confirm the correct placement of the catheter and this examination revealed a malposition of the catheter tip into the chest (Figure 1).

**Figure 1:** X ray of the chest revealing malposition of the catheter.

We removed this catheter without incident and placed a femoral catheter.

As the position of the catheter cannot be assessed during the procedure, we encourage physicians to check the position of the catheter by a chest X-ray immediately after the procedure is completed and before the catheter is used to ensure that it is in the correct position.

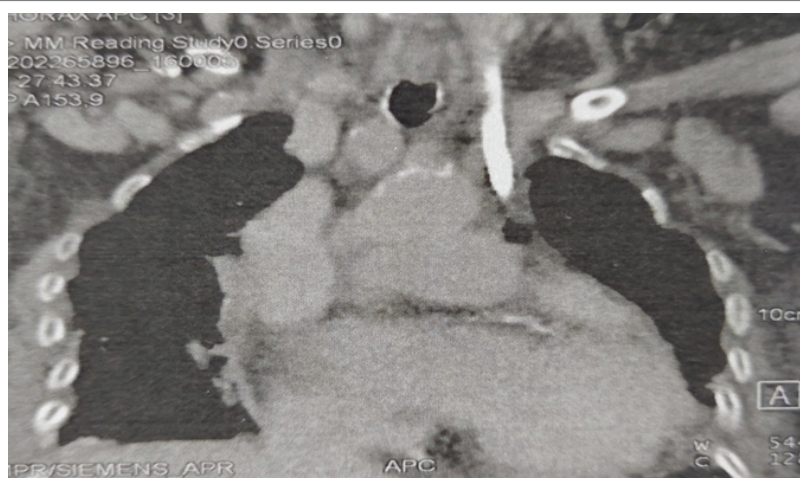
In order to be sure of the path taken by the catheter, we completed a thoracic angioscanner with 3D reconstruction (Figures 2 and 3) showing a branch at the level of the left brachiocephalic venous trunk with a catheter located in the mediastinum adjacent to the pericardium.

**Figure 2:** Axial CT scan confirming the malposition.

For our patient, we suspect that the introducer damaged the brachiocephalic venous trunk and the guidewire followed the path of this introducer and the catheter.

Our patient was stable during the procedure and even after there was no blood return which made us doubt of the diagnosis by evoking a persistent left superior vena cava but the angio CT scan confirmed the malposition in the mediastinum.

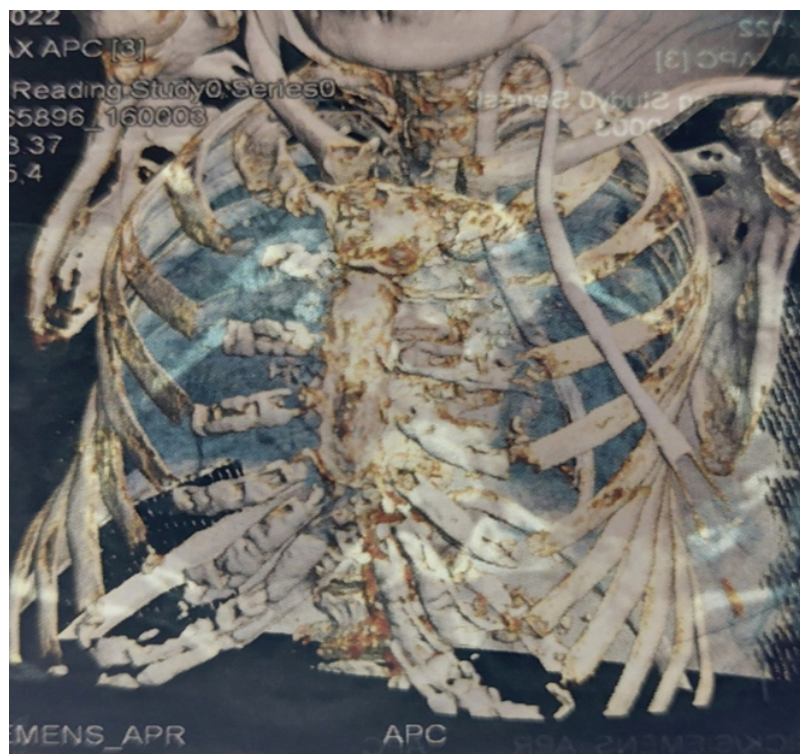
**Figure 3:** 3D reconstruction showing misplacement.
